Manhole Inspection Summary

Manhole # S37II_025MH

Insp Date: **3/15/07 12:59 PM**

Location Address: **1501 GREENMOUNT AVE**

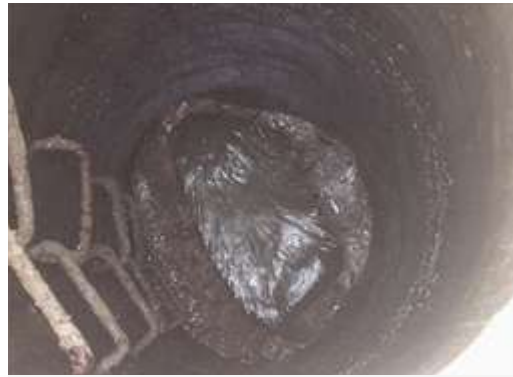
Top View

Bench ☒ Exists Material: **Unknown** ☐ Parged ☒ **Debris** (not Condition related)

Steps Count: **10** Missing: **0** ☒ **Corroded**

Surcharge ☒ **Evidence Of Surcharge** Depth: **5** (ft.) ☐ Active Surcharge Present

Corroded steps. Evidence of surcharge - Bench debris.

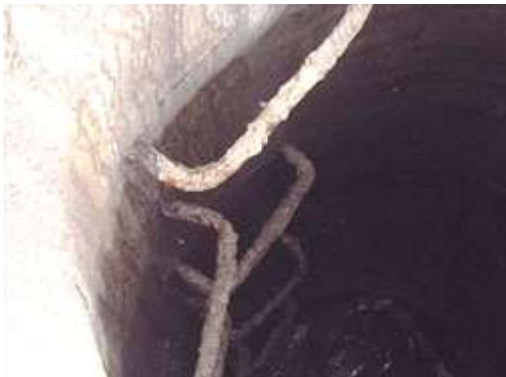
Defect

Infiltration: ☐ None ☒ **Joint** ☐ Cracks ☐ Mortar ☐ Roots ☒ **Wall**

Adjustment infiltration.

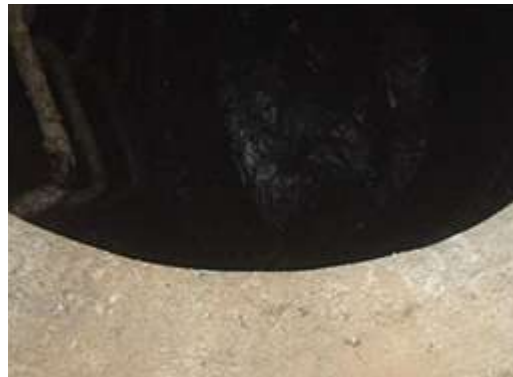
Defect

Frame Offset: **3** (in.) Condition: ☒ Sound ☐ Cracked ☐ Leaks

Frame offset.

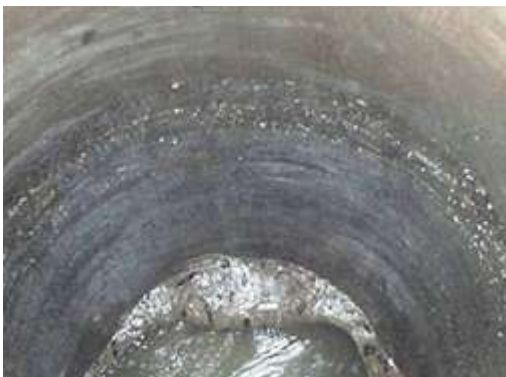
Defect

Evidence of surcharge.

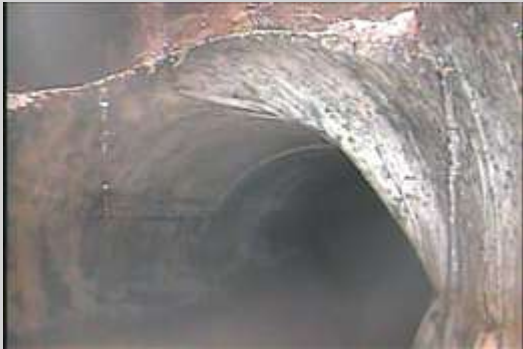
24 in. Circular Gravity Sewer Pipe Out @ 12 O'Clock

Pipe Material: **Unknown** ☒ Pipe Lined

Invert Depth: **17.94** (ft.) Flow Characteristics: **Fast**

Infiltration: **None** Pipe Seal Cond: **Unknown**

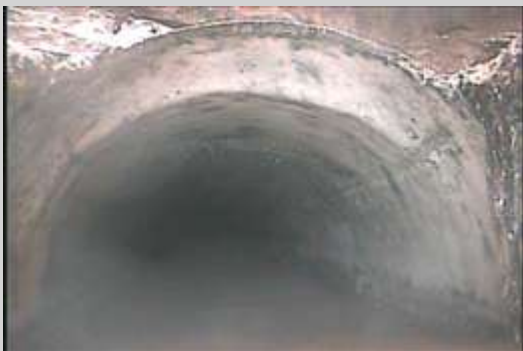
24 in. Circular Gravity Sewer Pipe In @ 5 O'Clock

Pipe Material: **Unknown** ☒ Pipe Lined

Invert Depth: **17.81** (ft.) Flow Characteristics: **Fast**

Infiltration: **None** Pipe Seal Cond: **Unknown**
